# The Simulation of the Fatal Crash Involving Diana, Princess of Wales, and Implications for the Investigation of Loss of Control Incidents

Iwan Parry Paul Fidler

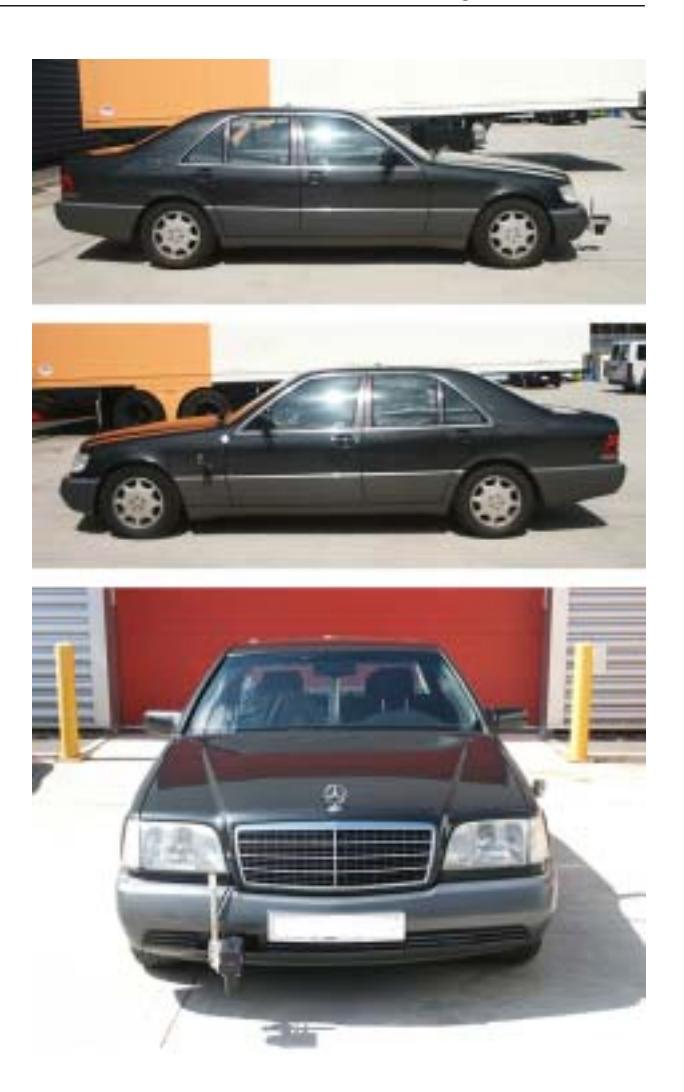
Fig. 1: The Mercedes 280 S test vehicle

These tests largely duplicated those for which test data had been provided for the 500 S and involved steady state cornering, step steer and a series of closed loop tests specifically intended to provoke similar responses from the vehicle as would have occurred during the incident. These tests involved rapid sequences of steering inputs of varying severity at speeds of 92 - 100 km/h (57 - 62 mph). The test vehicle instrumentation is shown in figures 1 and 2.

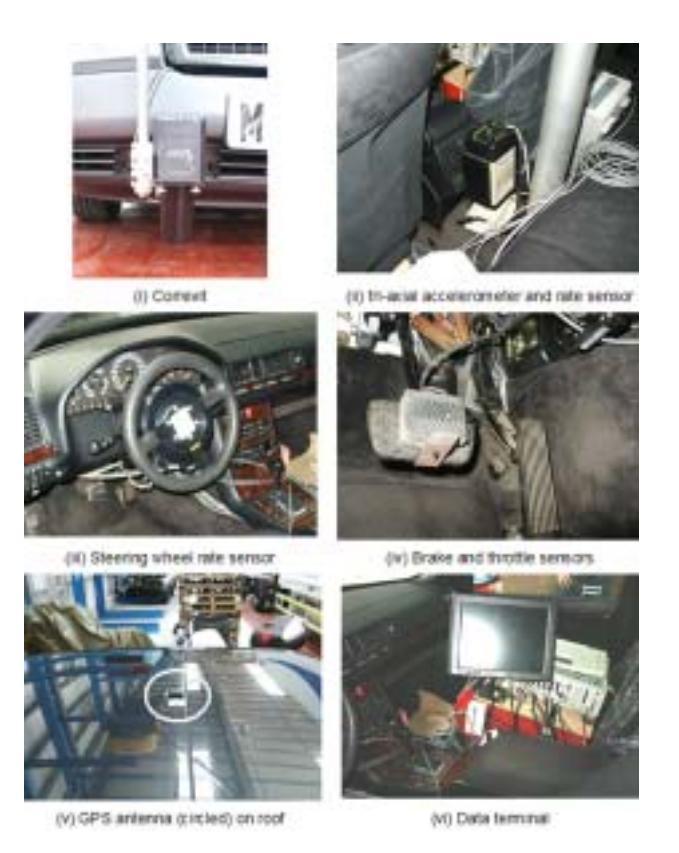
Fig. 2: Test equipment fitted to the Mercedes 280 S

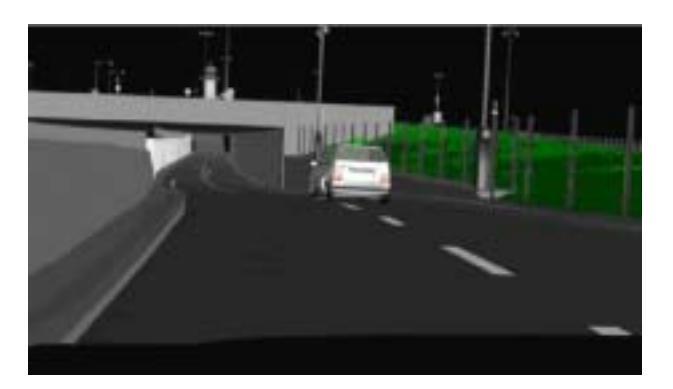
Fig. 3: The simulation environment

lar within the underpass, in a position and orientation consistent with those reconstructed from the physical evidence and damage to the incident vehicle, figures 3 and 4.

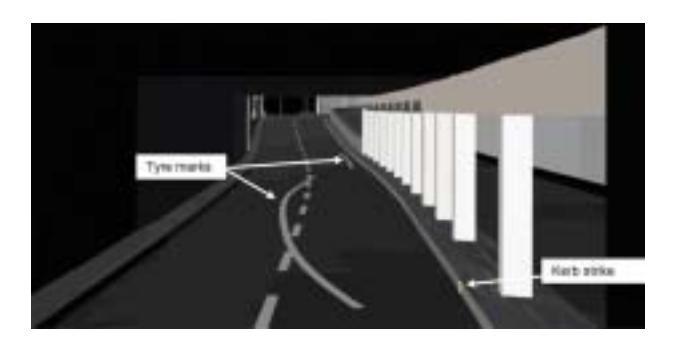
Fig. 4: The tyre mark locations as represented within the environment model

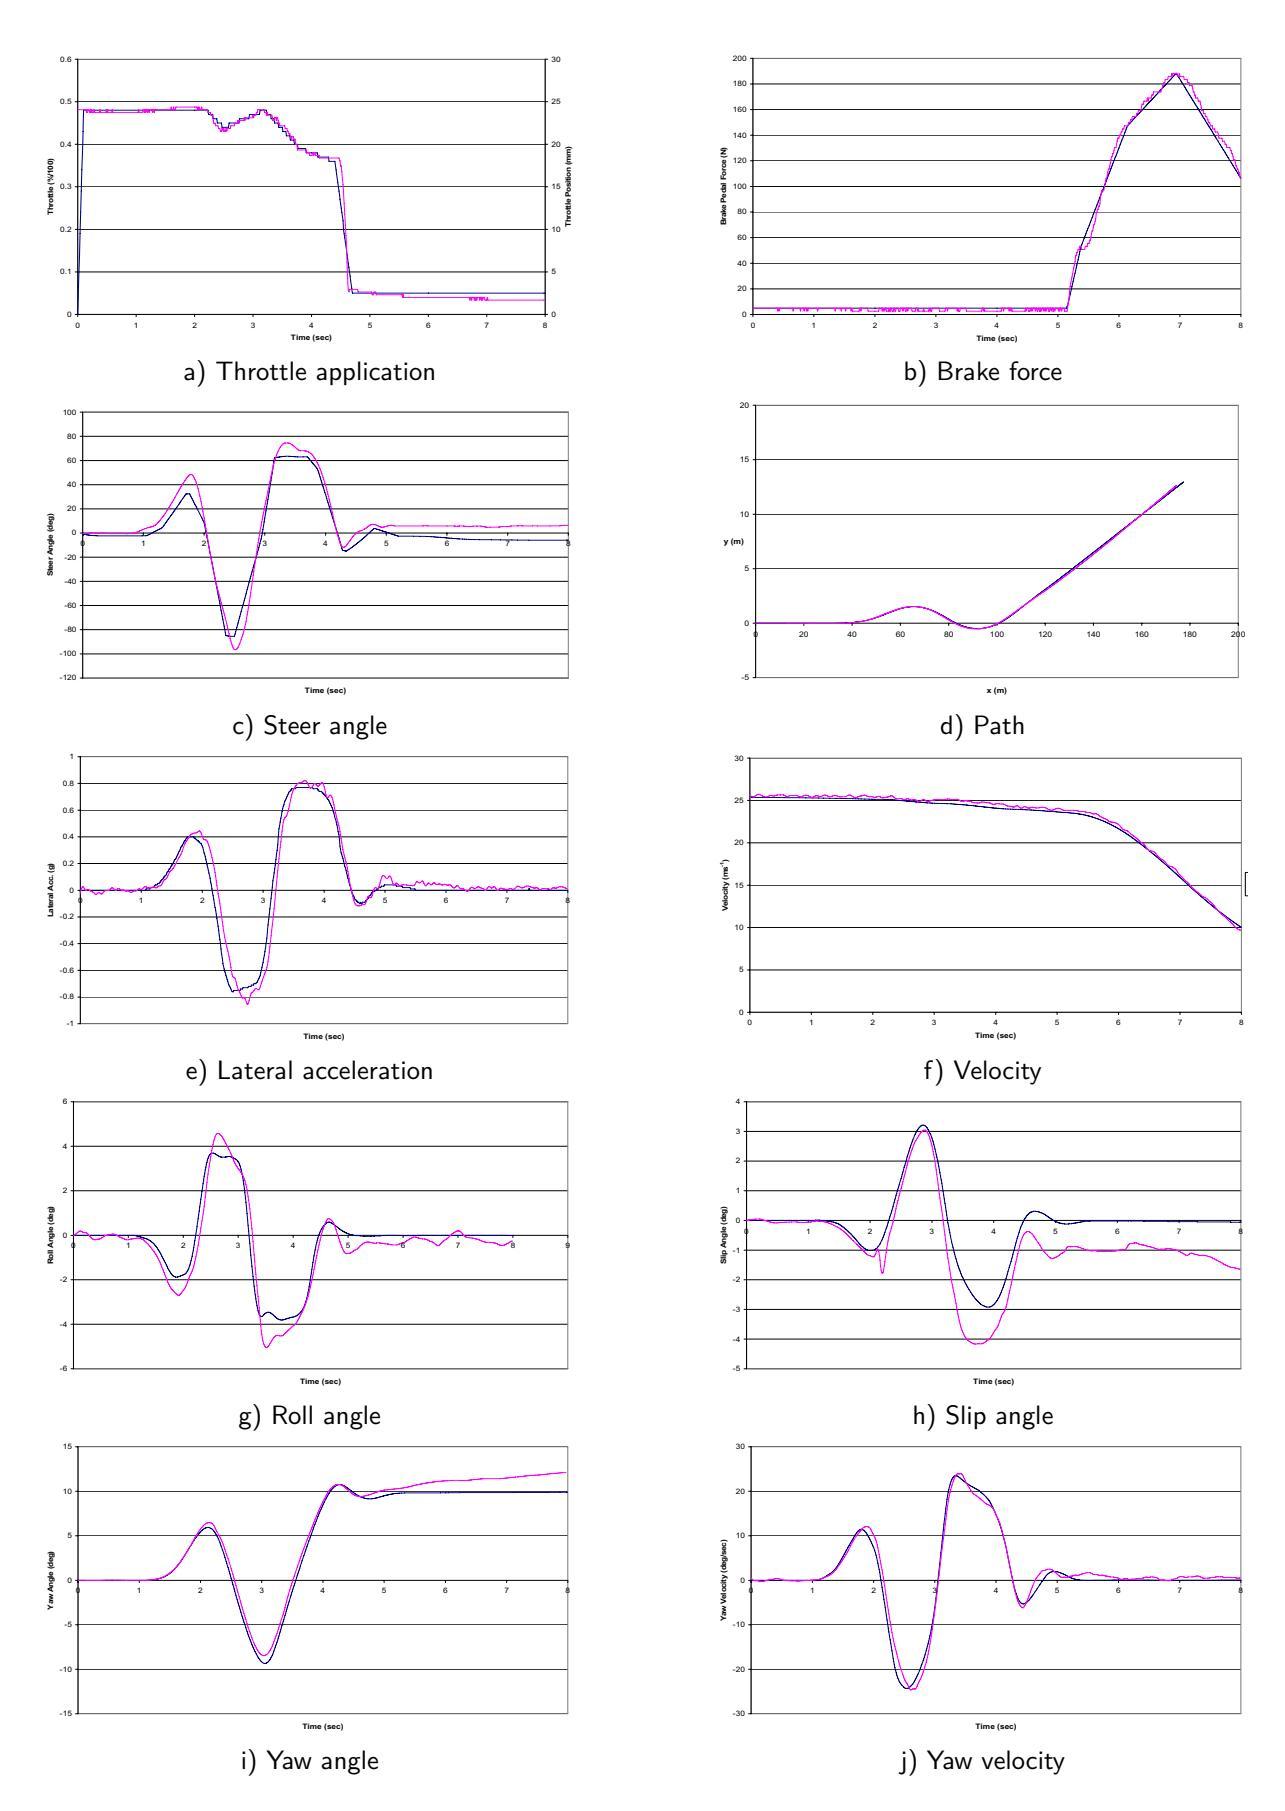
Fig. 5: Results of the first simulation run – Magenta curves = TRL test; blue curves = simulation

Tests with a comparison Mercedes 280 S vehicle were undertaken on TRL's research track in May 2006 and provided an independent set of test data relating to the handling characteristics of the 280 S. The instrumentation fitted to the test vehicle provided a comprehensive record of the driving and vehicle response in each test. TRL physical tests included; steady state cornering (12 tests), step steer (26 tests) and severe steering (14 tests). The severe steering tests were undertaken in an attempt to provoke oversteer and to recreate, as closely as possible, the type of handling situation encountered by the incident vehicle during the loss of control in the Pont de l'Alma underpass. In running comparative simulations of the physical tests, sensitivity analyses of specific input parameters were undertaken to investigate the effects of variations on the speed and path of the vehicle. The results of two tests are presented in figures 5 and 6.

As can be seen from the results, the Mercedes 280 S simulation model generated data which closely matched that from the physical test vehicle. These results were obtained with only one significant modification to the vehicle model (which was initially made to the 500 S model) this being a modification of the lateral force verses slip relationship at the rear tyres. This modification was made in response to excessive rear tyre slip (causing oversteer) of the simulation vehicle, which was found during early sim-

The steering and suspension systems within HVE could not simulate precisely the steering effect of each road wheel with respect to a particular level of steering wheel input from the driver (and in response to particular severities of cornering). This may have been due to a number of effects including, passive steering, non-linearity in the steering system and/or limitations of the simulation type model. These effects increased the effective steering input for the simulation vehicle in severe steering manoeuvres, and required that actual steering inputs to the simulation model were reduced in comparison to known test steering inputs. The degree of difference between the steering inputs to the Mercedes 280 S tested at TRL, and those to the simulation vehicle in the validation tests can be seen in figures 5c and 6c.

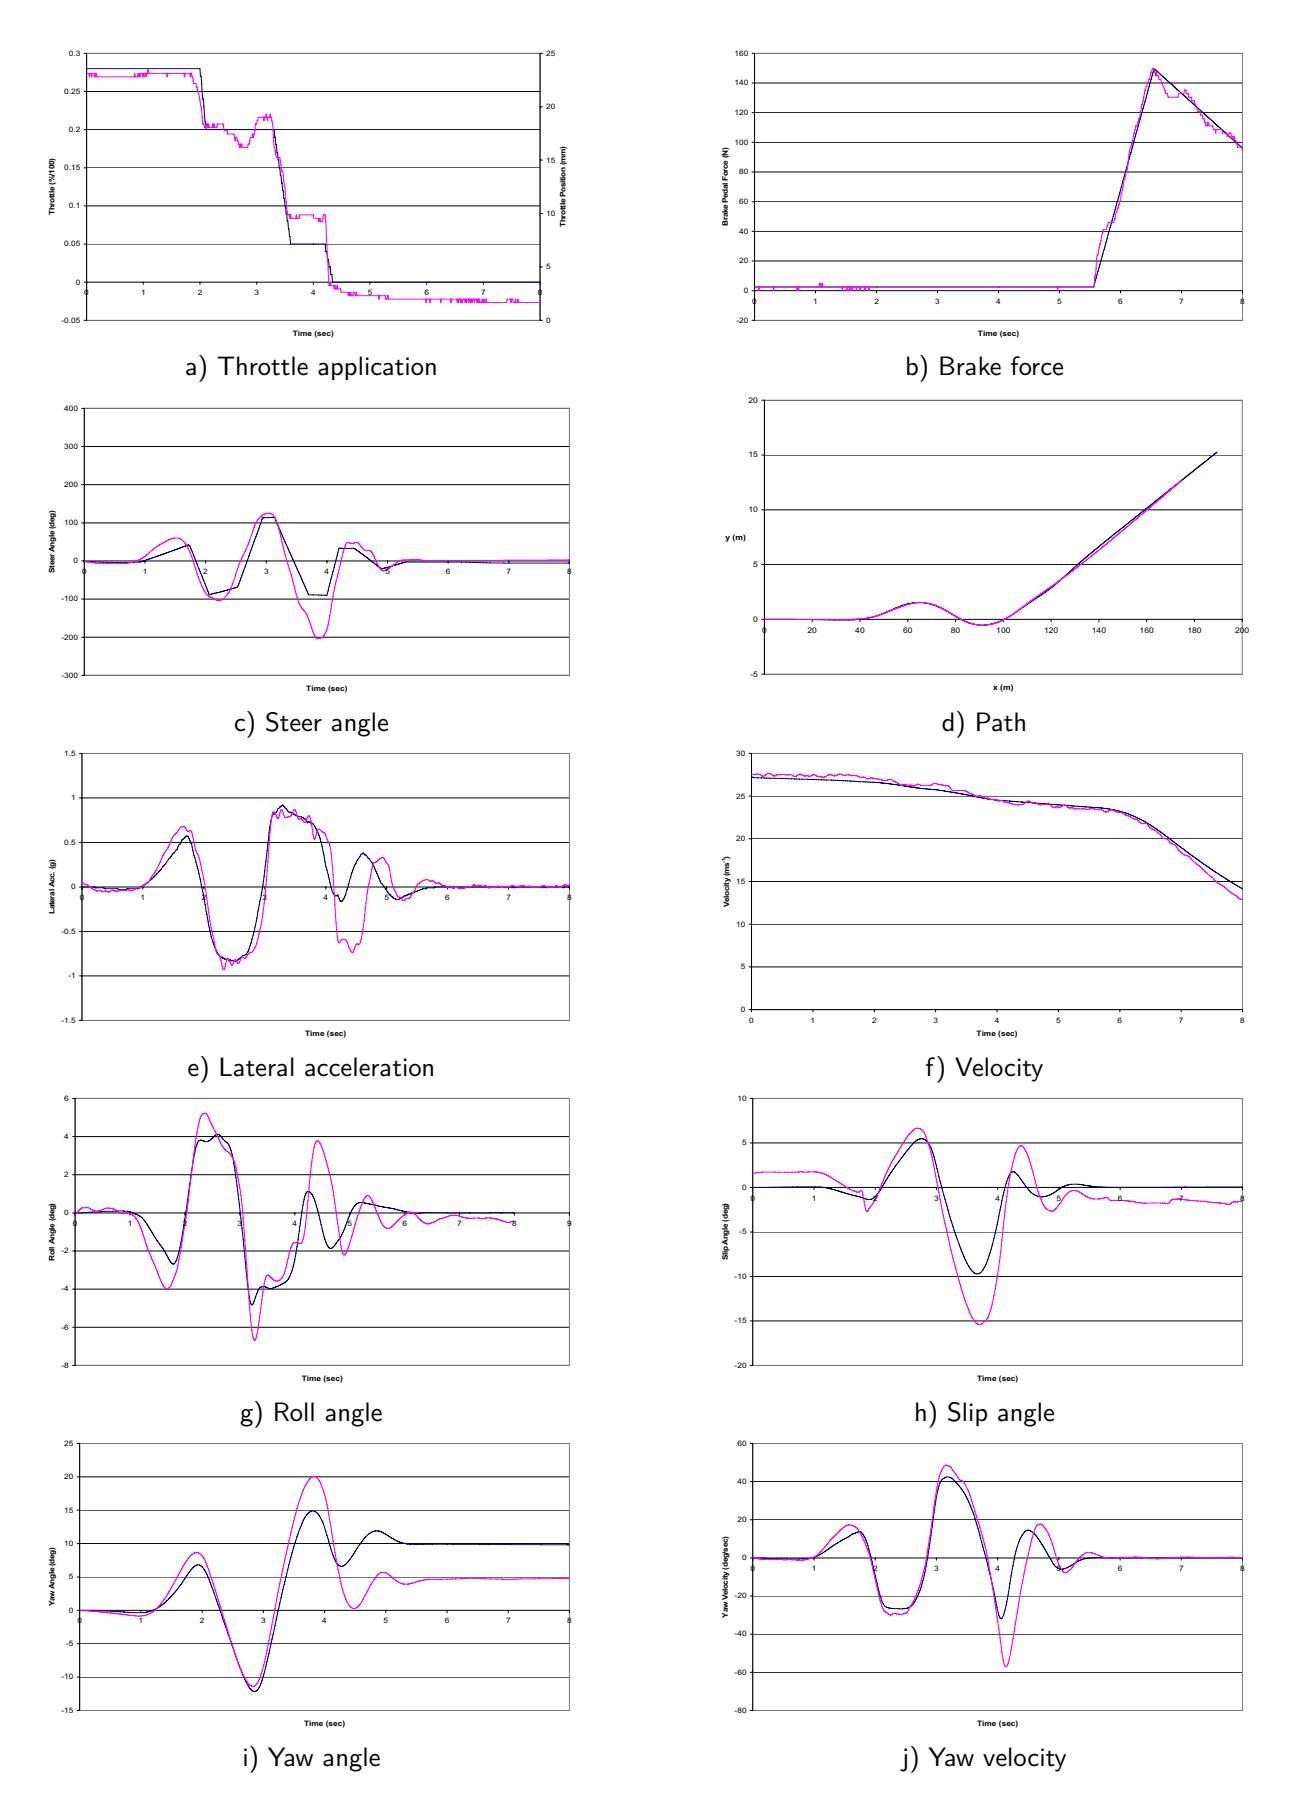
Fig. 6: Results of the third simulation run – Magenta curves = TRL test; blue curves = simulation

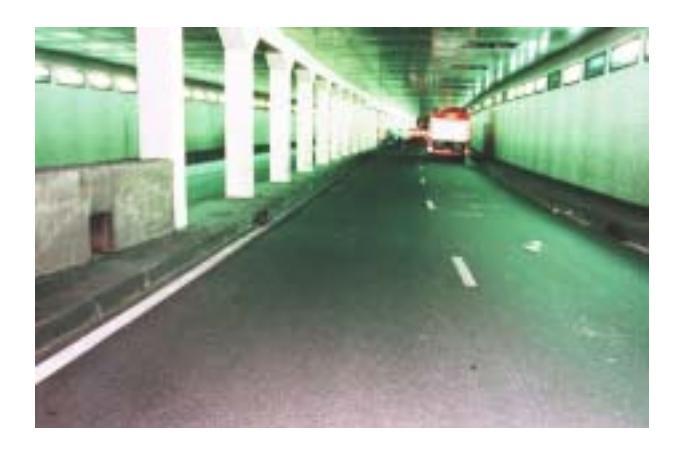
clear and red fragments of vehicle light unit debris – these were found within the right lane of the west bound carriageway close to the entrance to the underpass;

Fig. 7: The entrance to the underpass and debris (note that the first tyre mark was identified in this area but is too light to be seen clearly)

The physical evidence found by the investigating authorities, figures 7, 8, 9 and 10, identified

The positioning of the debris, relative to the tyre marks, would suggest that the collision must have taken place centrally or towards the right of

the carriageway and a short distance from the entrance to the underpass. If the contact between the vehicles occurred in the left lane the debris would have been thrown laterally (to the right) from the point of collision before coming to rest. In the absence of a significant left to right impulse on this debris such movement is unlikely.

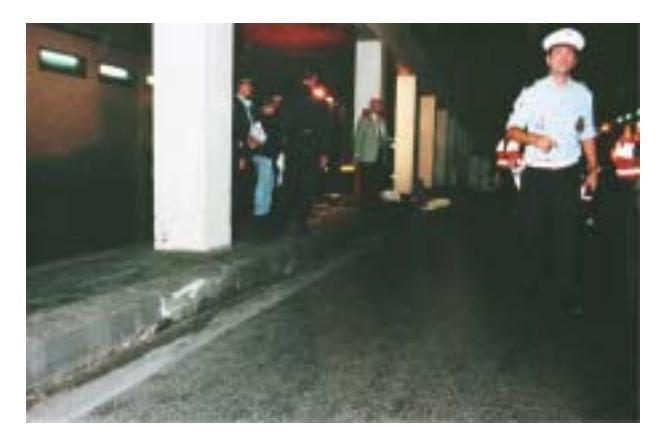
- marks and abrasions consistent with a wheel impact with the central kerb of the westbound carriageway a short distance in advance (to the east) of the point of collision;

Fig. 9: The kerb strike and the area leading to the pillar impact

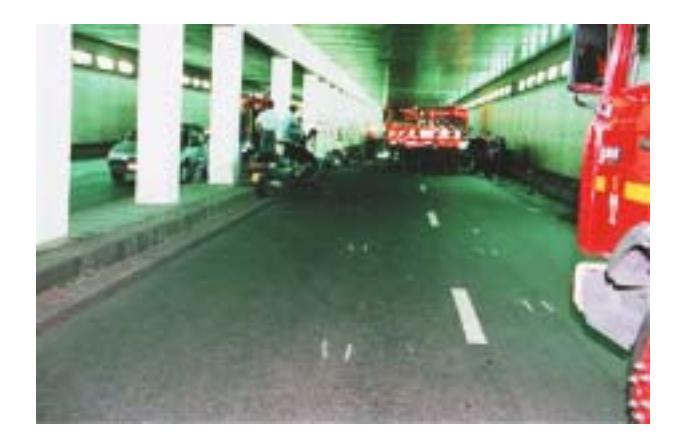
an initial tyre mark located within the left lane which was initially angled slightly towards left kerb of the carriageway, but which then curved right towards the nearside (right) lane. The implication of this mark being that the Mercedes would have travelled from right to left across the carriageway before being steered to the right, away from the central kerb. It was not known exactly where the contact occurred with the Fiat however the lens debris was found a short distance into the underpass and in the right-hand lane.

Fig. 8: The tyre marks leading toward the kerbstrike and the point of collision with the central pillar

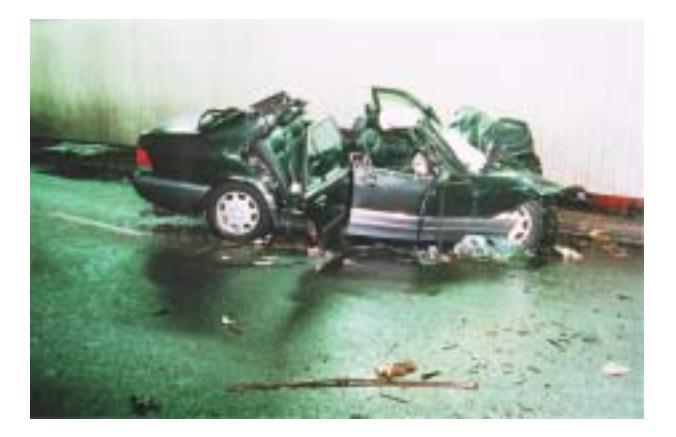
- damage to the pillar which was struck by the Mercedes; debris in the vicinity of the impact; and the rest position and orientation of the Mercedes following the collision;

Fig. 10: The vehicle in its rest position

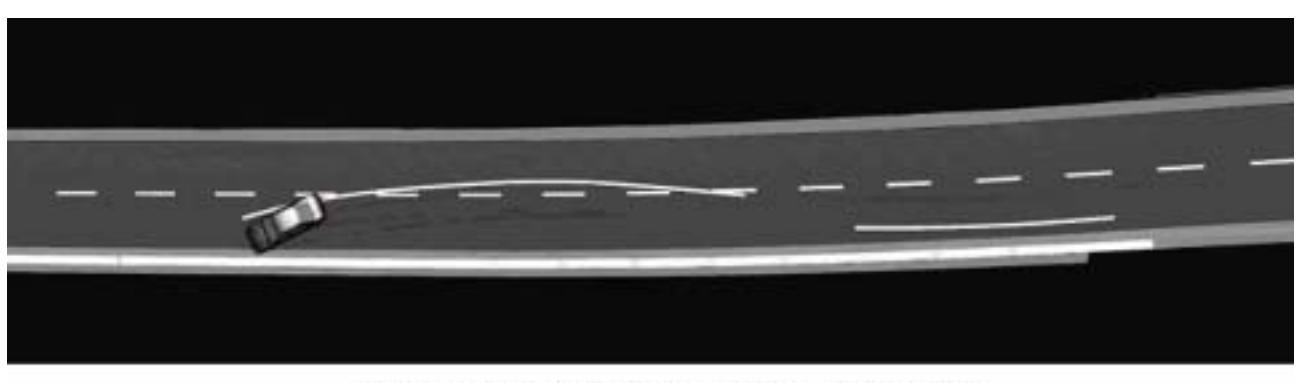
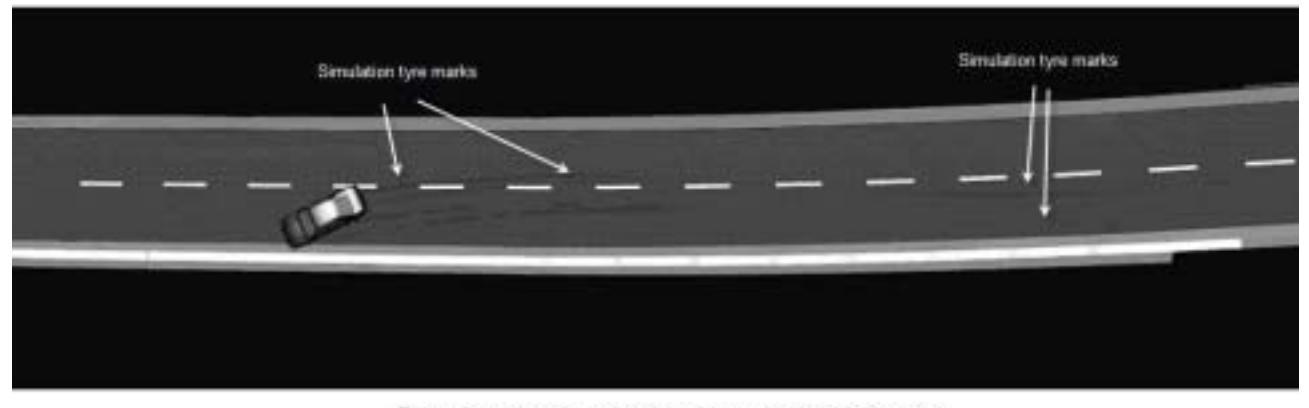
Fig. 12: Comparison of actual and predicted tyre mark location

Plan view showing evidential tyre marks overlayed (white)

Plan view showing simulated tyre marks (dark grey)

Simulations using the validated 280 S vehicle model in HVE have indicated that, for specific conditions of vehicle speed, driver steering input and allowing reasonable assumptions for road surface friction it is possible for the vehicle model to travel the path defined by the type marks, for the front left wheel to strike the kerb at the point of the wheel/kerb impact observed at the scene, and for the vehicle to reach a point of impact with the central pillar that is consistent with the location and orientation of damage sustained during the collision. Importantly, the areas where tyre marks were identified on the road surface coincided with the areas in which simulation model generated maximum lateral acceleration, type slip and weight transfer to the types on the side of the vehicle that created the marks, figures 11 and 12.

It was found that an initial approach speed of  $108 - 115 \,\mathrm{km/h} (67 - 71 \,\mathrm{mph})$  provided very strong agreement between the simulation vehicle path and the path of the type marks found at the incident site, the location of the kerb strike, the orientation of the vehicle at this point and the orientation and heading of the vehicle at the point of impact with the central pillar. The incident simulations predicted a pillar impact speed of 96 - 104 km/h (60 - 65 mph) which was highly consistent with the impact speed of  $105 \,\mathrm{km/h}$  $\pm 5 \text{ km/h}$  (65 mph  $\pm 3 \text{ mph}$ ) estimated during the initial investigation by the French investigators using data from two the impact tests performed by the vehicle manufacturer at test speeds of 95 and  $109 \,\mathrm{km/h}$  (59 and 68 mph). Since the simulation and the impact test techniques were independent in their means of speed estimation, they provide strong support of one another.
